Attachment B

Recent Development in Reach B of Mammoth Creek

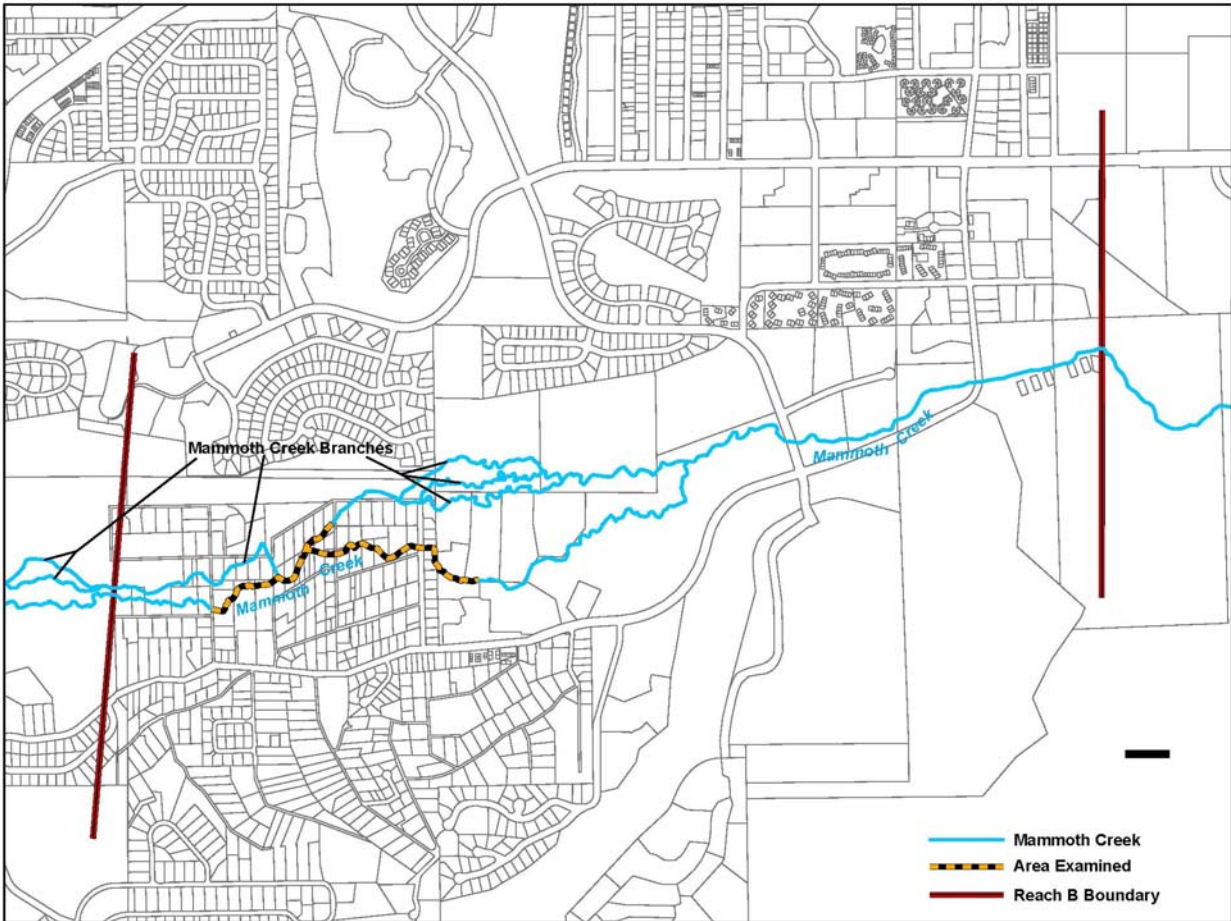
Figure B-1. Reach B of Mammoth Creek, showing the multiple branches of the creek and the area visually examined during September 2007.

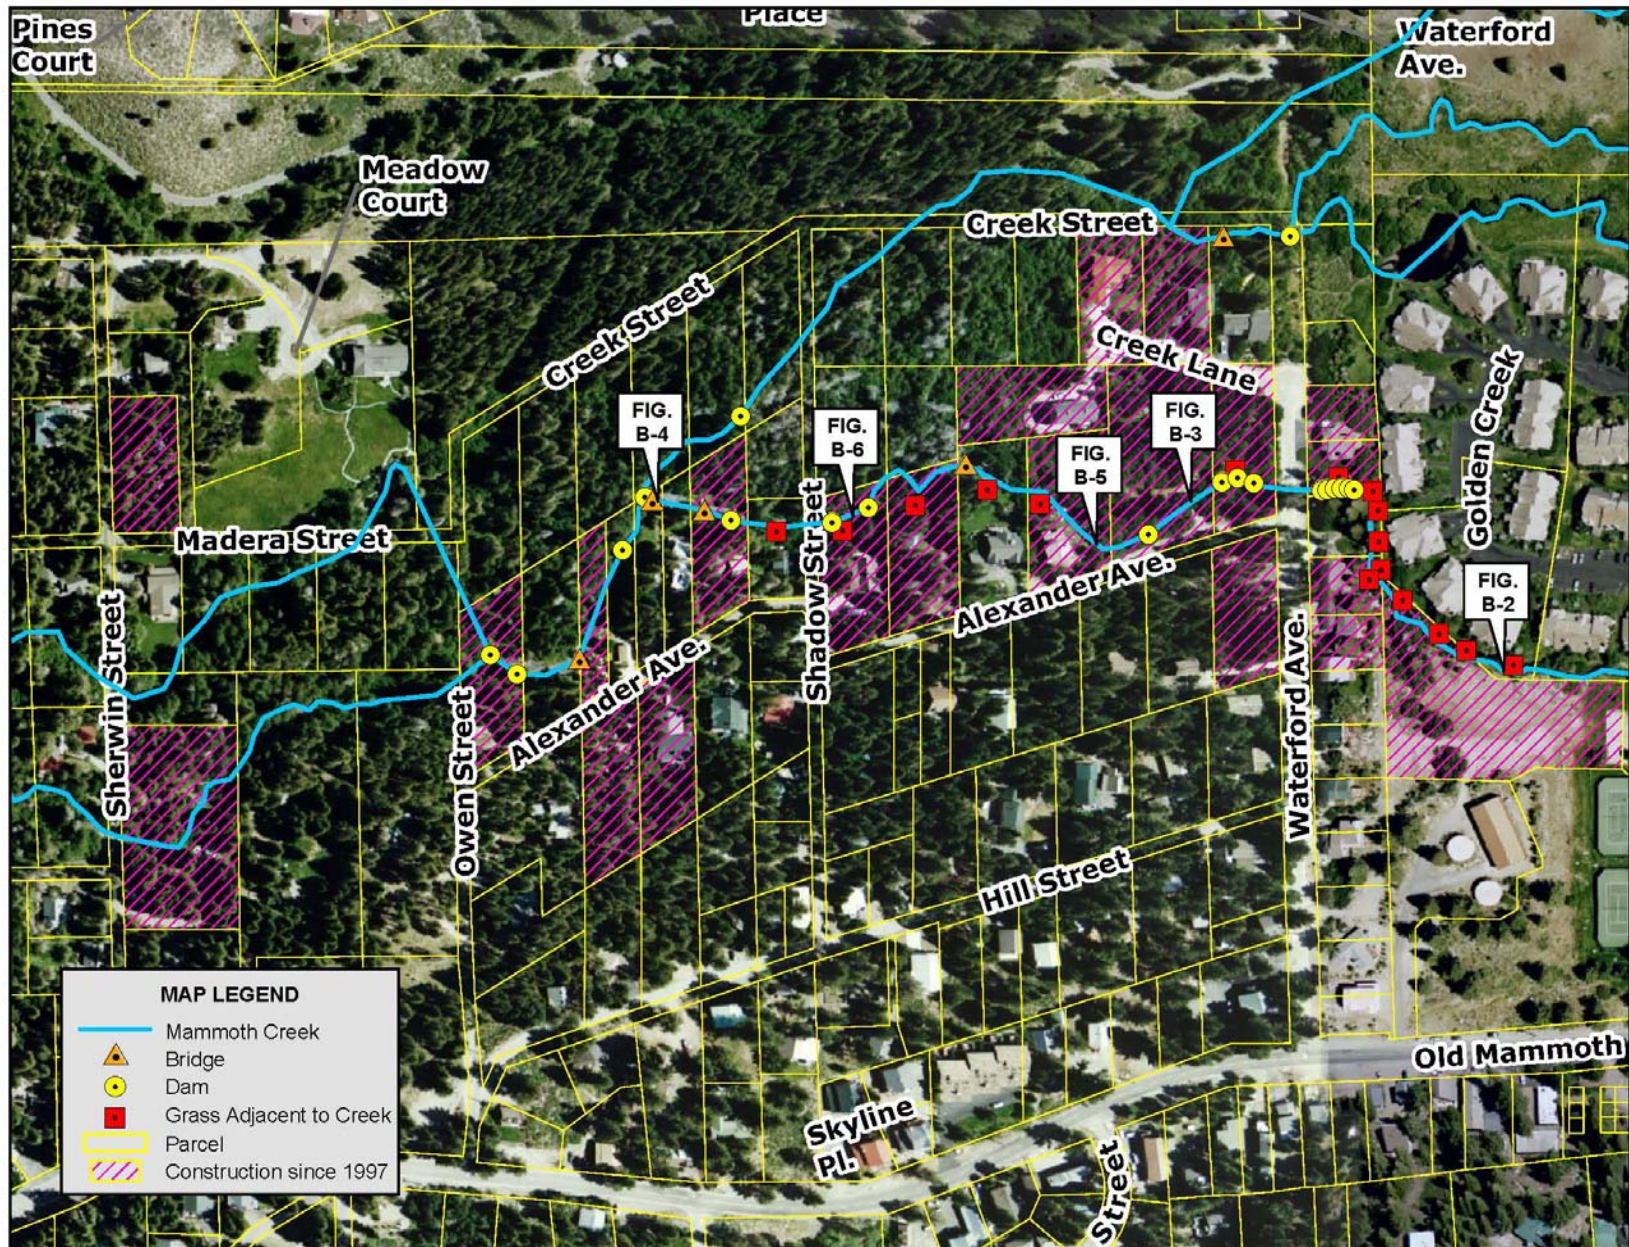
Compiled development permit information and observed habitat disturbances within and along Reach B of Mammoth Creek are presented in **Figure B-2**. Examination of Figure B-2

demonstrates that a substantial amount of residential development and habitat disturbance activities have recently occurred along Mammoth Creek between Sherwin Street and Snowcreek.

Figure B-2. Compiled development permit information and observed habitat disturbances within and along Reach B of Mammoth Creek.

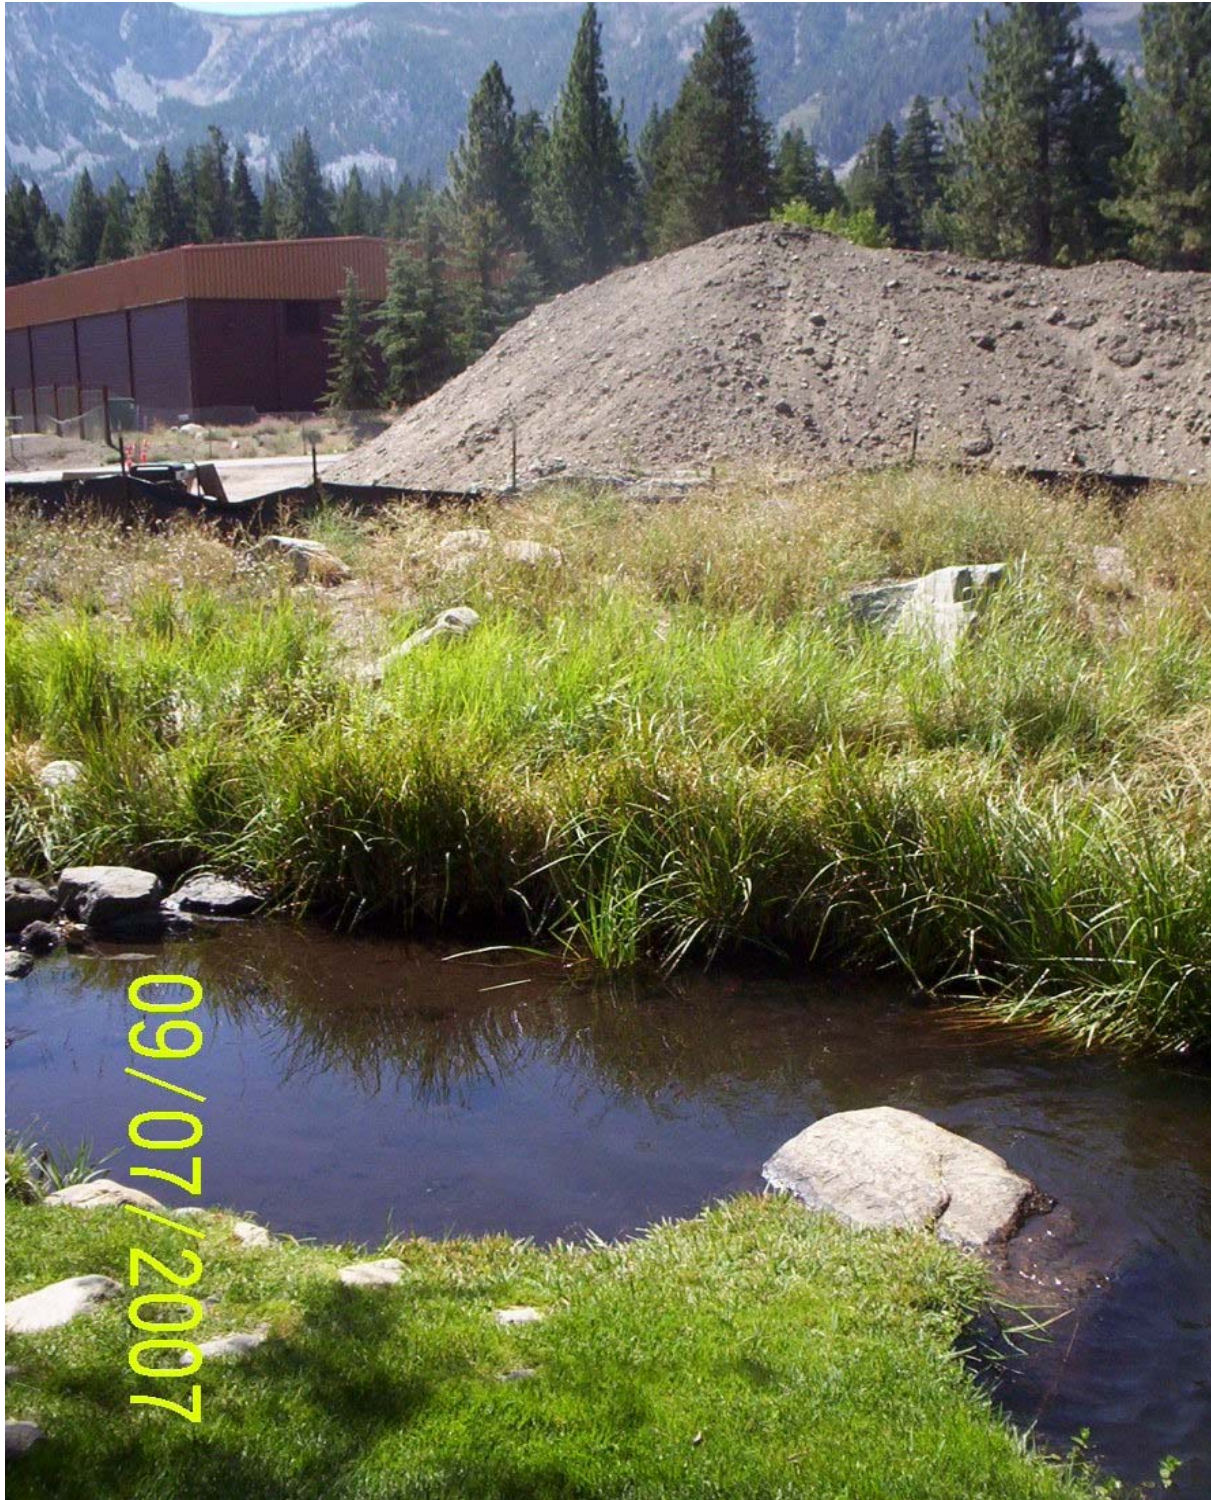
Figure B-3. Ongoing development across Mammoth Creek from Snowcreek IV, near MCWD's groundwater treatment plant.

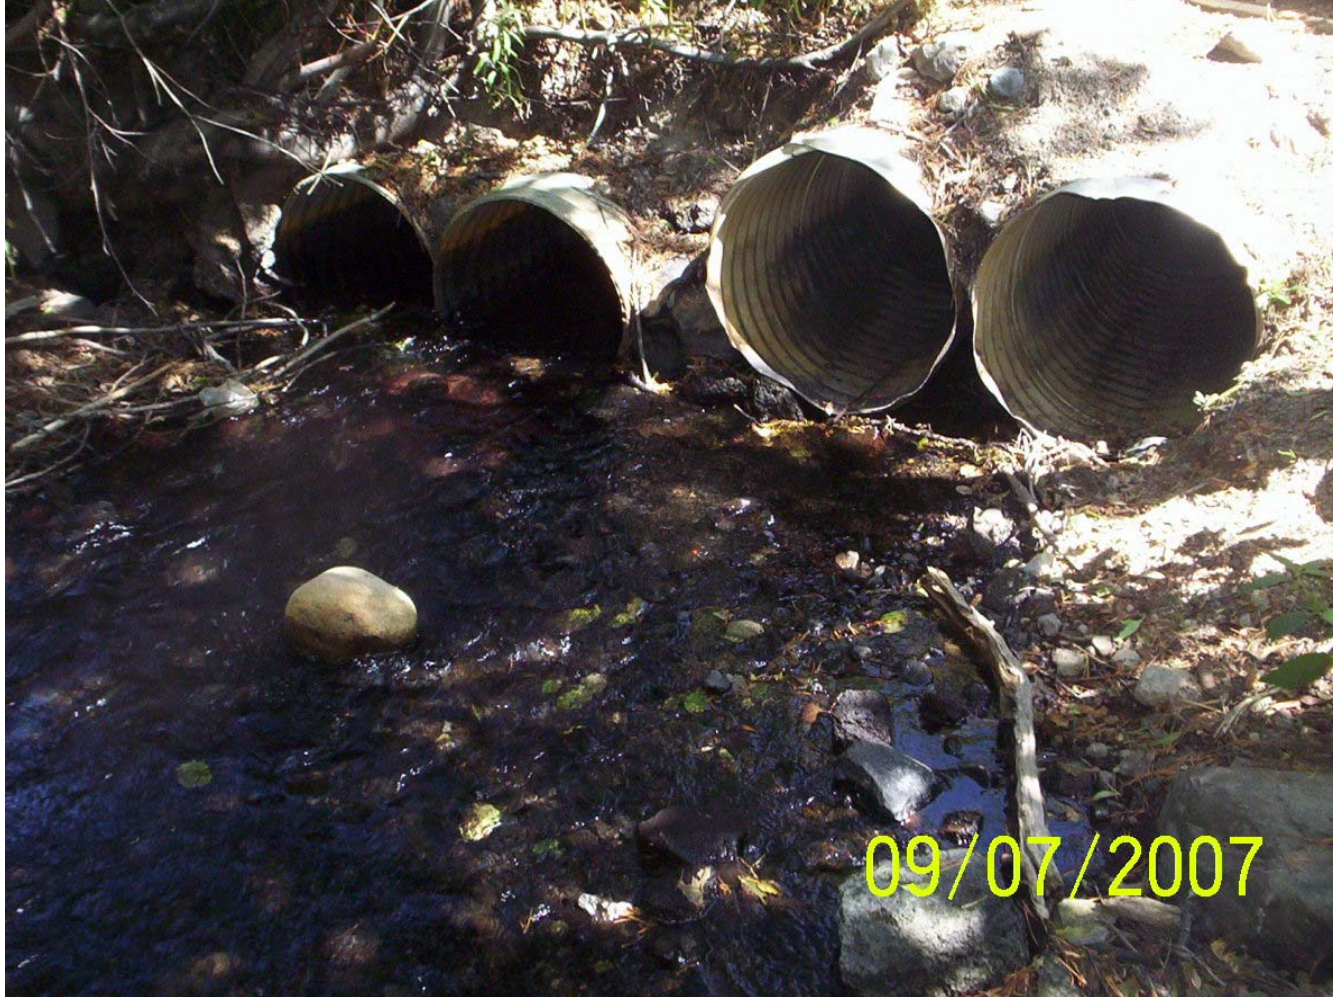
Figure B-4. A culvert installed in Reach B of Mammoth Creek as part of a driveway to provide access to a private residence.

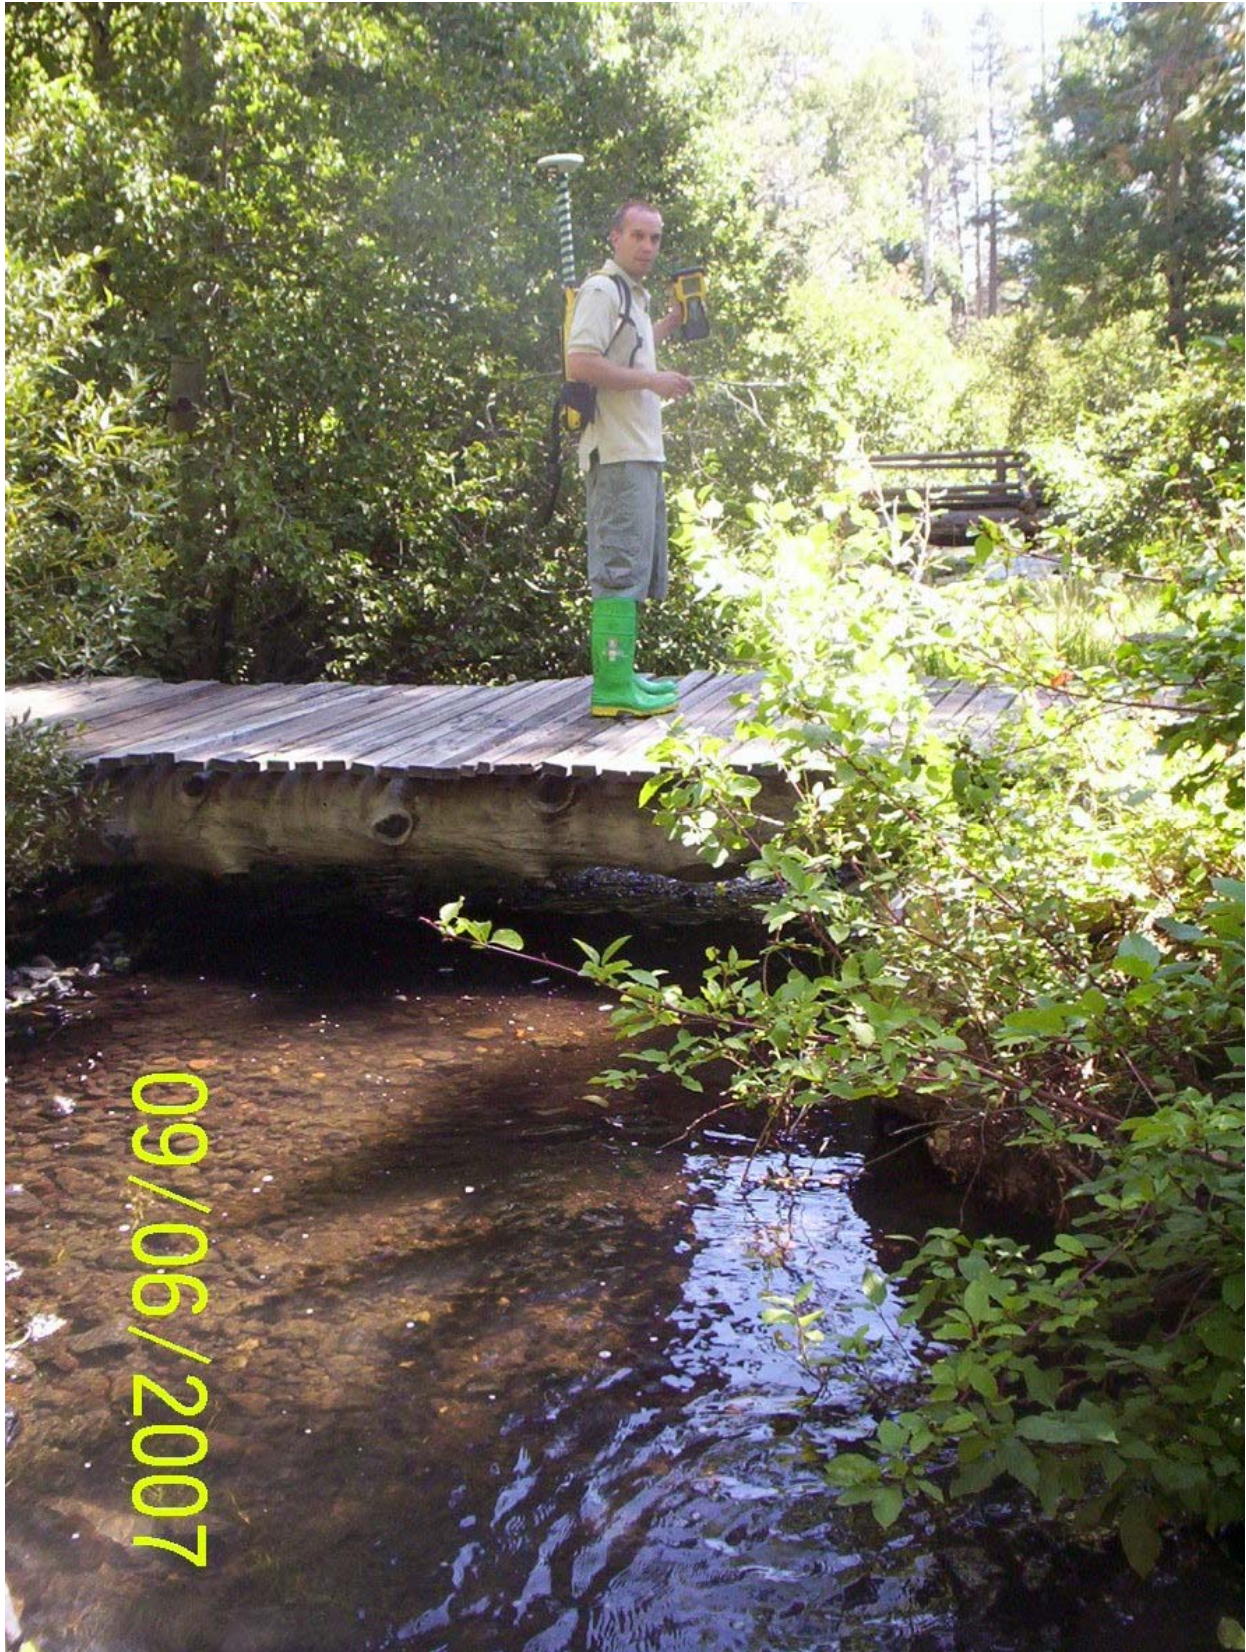
Figure B-5. Multiple bridges installed in Reach B of Mammoth Creek.

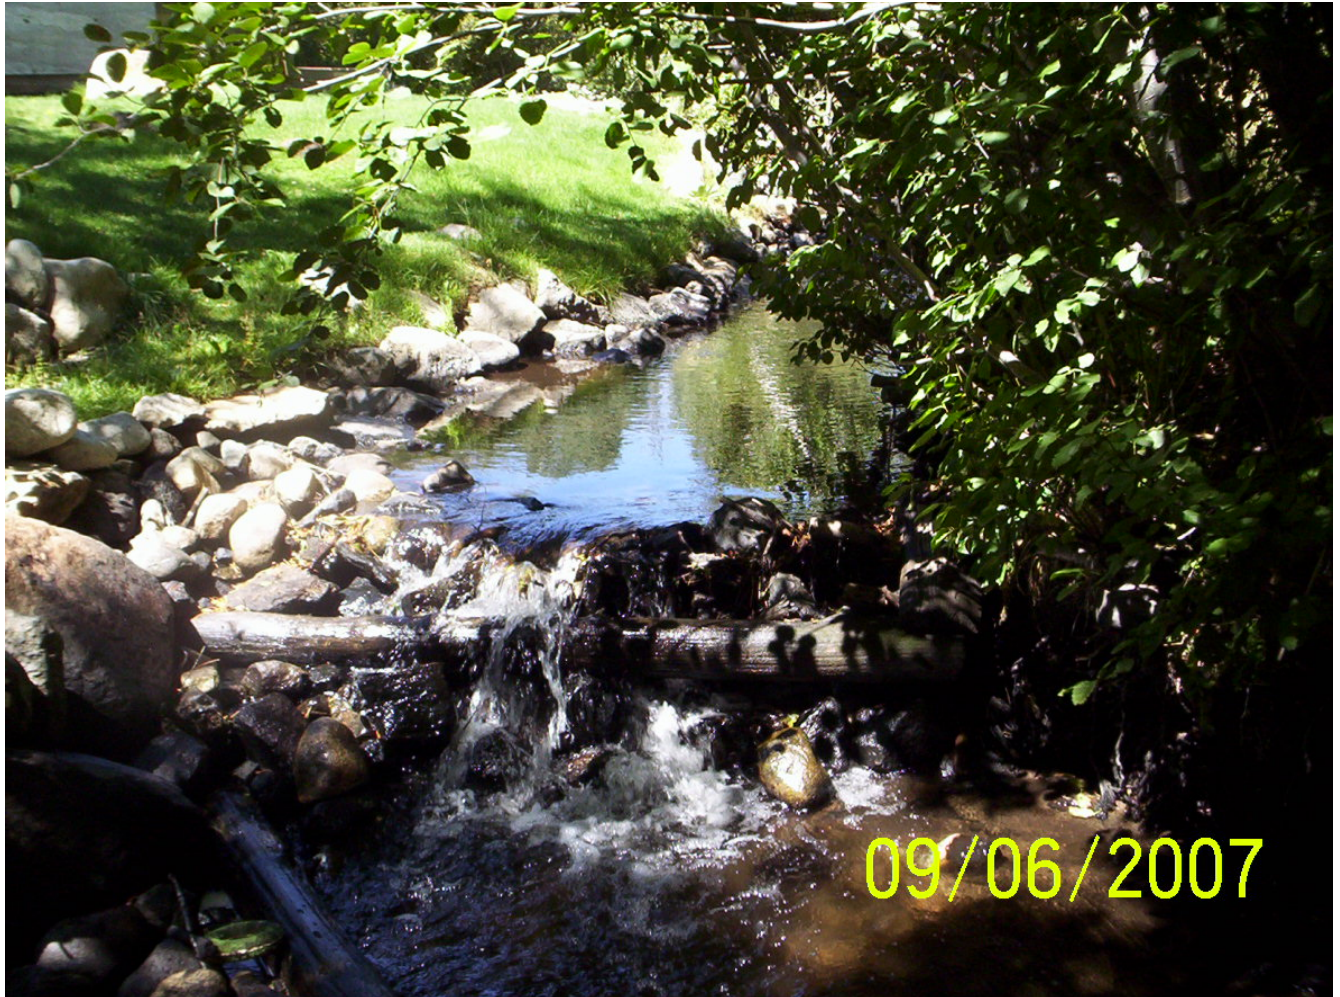
Over thirty dams were counted in Mammoth Creek between Sherwin Street and Snowcreek. Some of the instream rock dams are substantial, and may have the potential to act as a fish barrier under low flow conditions. Two dams were observed on many parcels, and one parcel had six rock dams installed within a small section of the creek.

Figure B-6. One example of instream rock dams constructed in Reach B of Mammoth Creek. Some of the instream rock dams are substantial, and may have the potential to act as a fish barrier under low flow conditions.

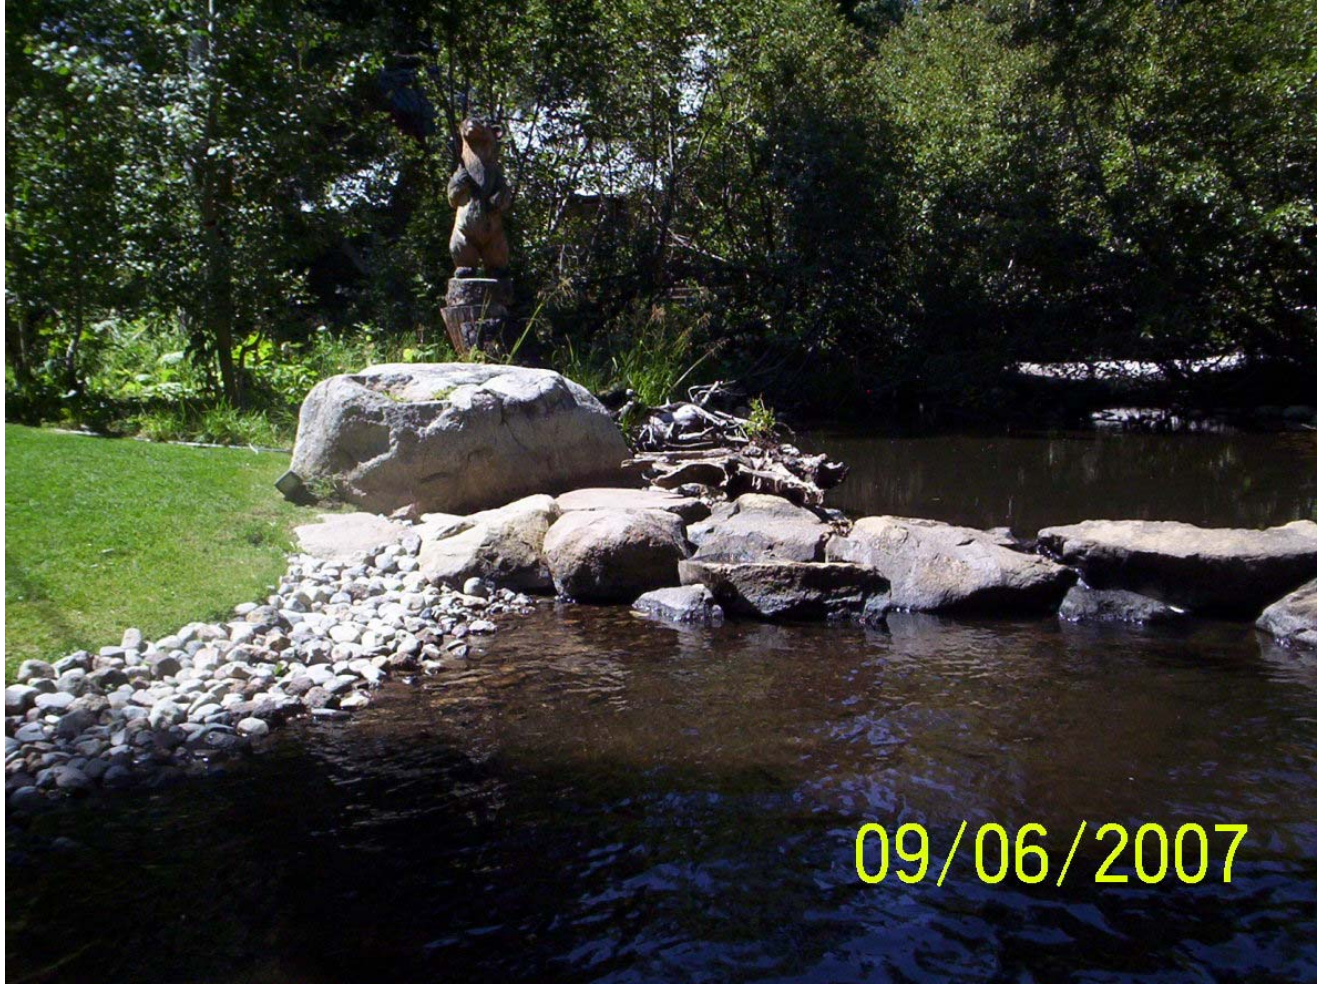
In addition to various residential development construction-related effects, many homeowners have directly influenced the creek in other ways. Twenty-two parcels between Snowcreek and Sherwin Street have modified the aquatic habitat of Mammoth Creek through the construction of rock dams within the creek, installing bridges over the creek, or installing turf directly up to the creek banks. Other influences include the installation of “drainpipes” directly feeding into the creek from unknown sources, creation of diversions and additional man-made channels, the dumping of grass clippings in the creek, and the installation of artificial decorative rock walls along the creek banks. One of the most common situations noted during the visual survey of Reach B of Mammoth Creek was the apparent reduction in water velocity associated with the installation of rock dams, which appear to have caused localized siltation in the creek.

Figure B-7. One example of a private parcel exhibiting grass installation up to the creek bank, rocks installed along the creek bank, and an instream rock dam.
