Appendix B

Recent Development in Reach B of Mammoth Creek

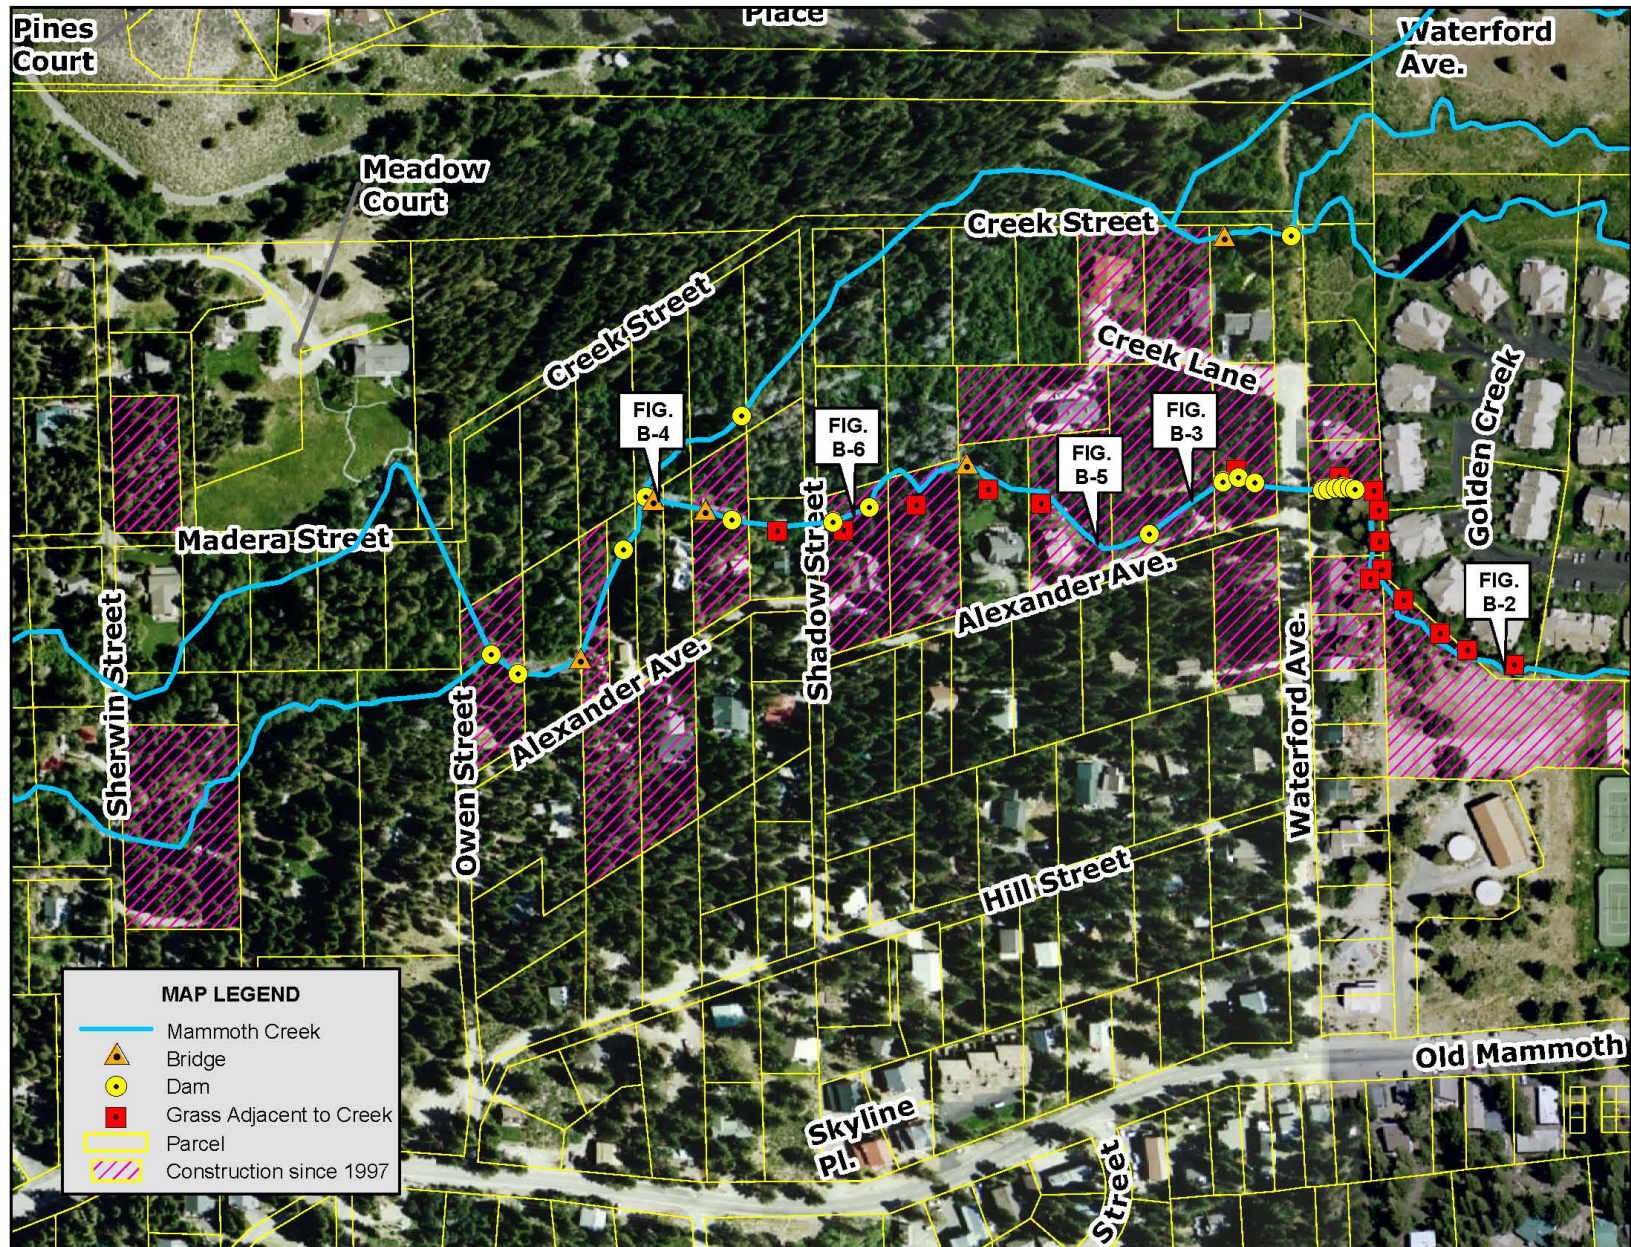
Compiled development permit information and observed habitat disturbances within and along Reach B of Mammoth Creek are presented in **Figure B-2**. Examination of Figure B-2

demonstrates that a substantial amount of residential development and habitat disturbance activities have recently occurred along Mammoth Creek between Sherwin Street and Snowcreek.

Figure B-2. Compiled development permit information and observed habitat disturbances within and along Reach B of Mammoth Creek.

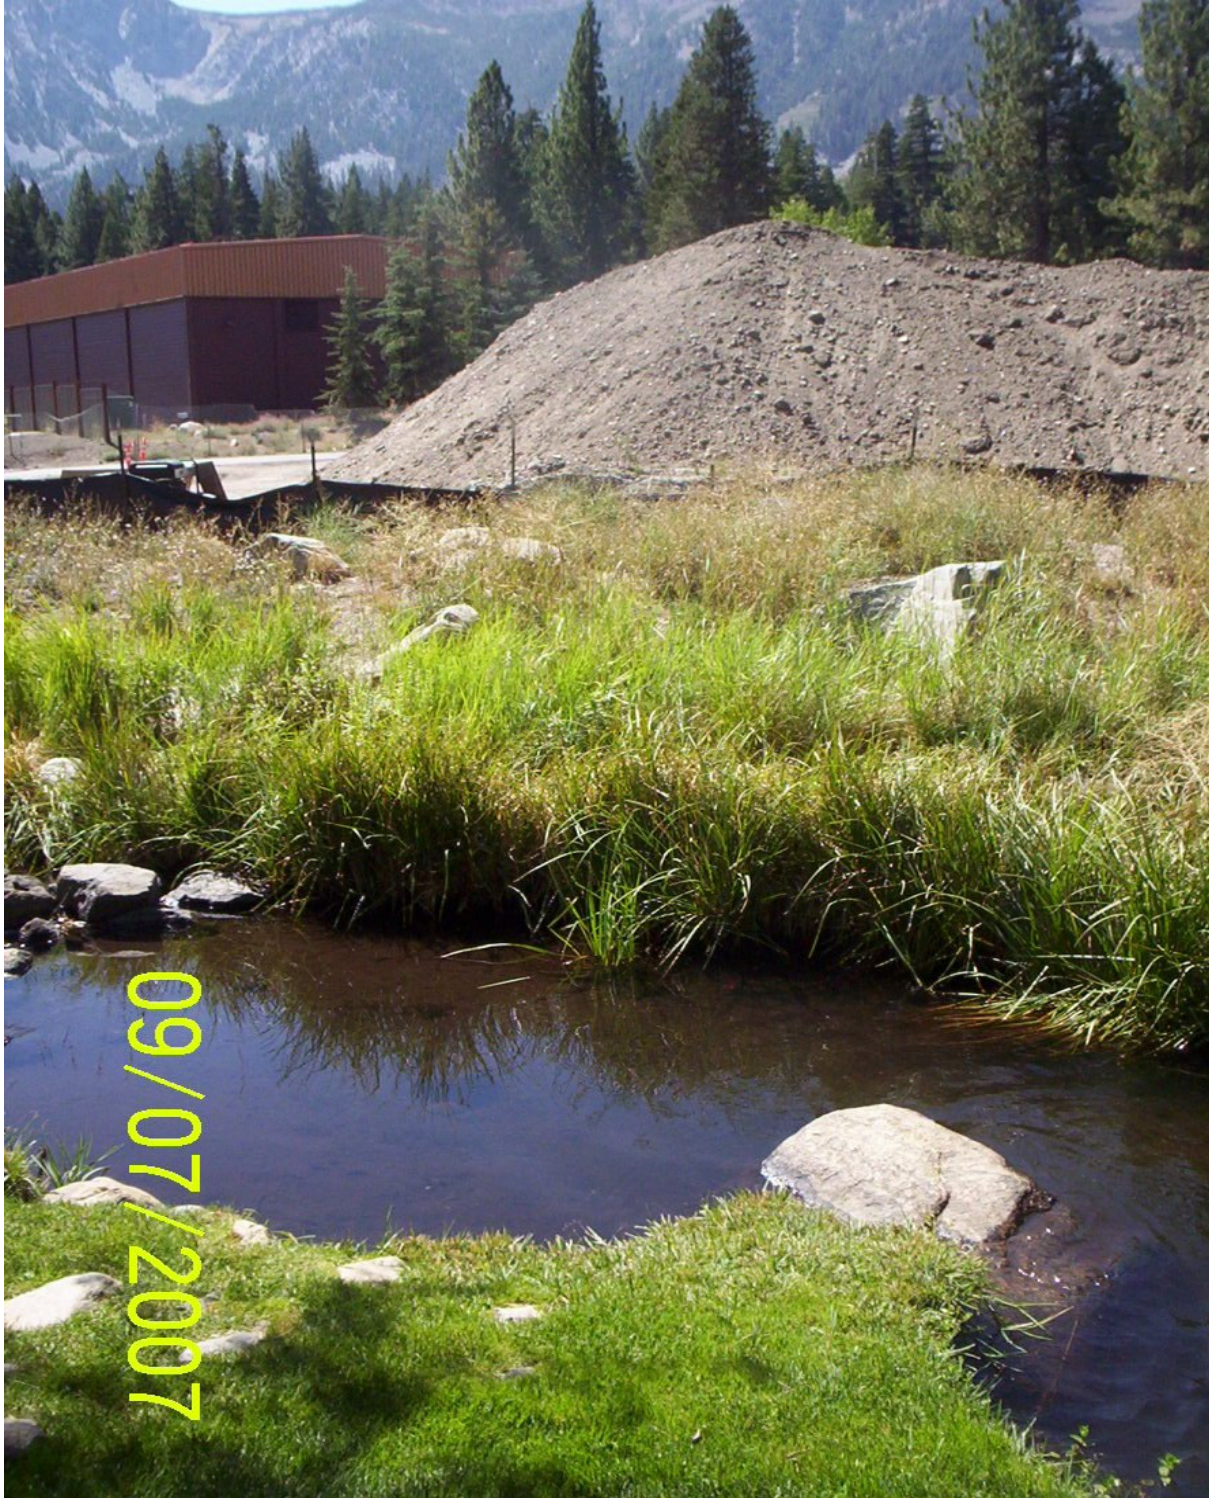
Figure B-3. Ongoing development across Mammoth Creek from Snowcreek IV, near MCWD's groundwater treatment plant.

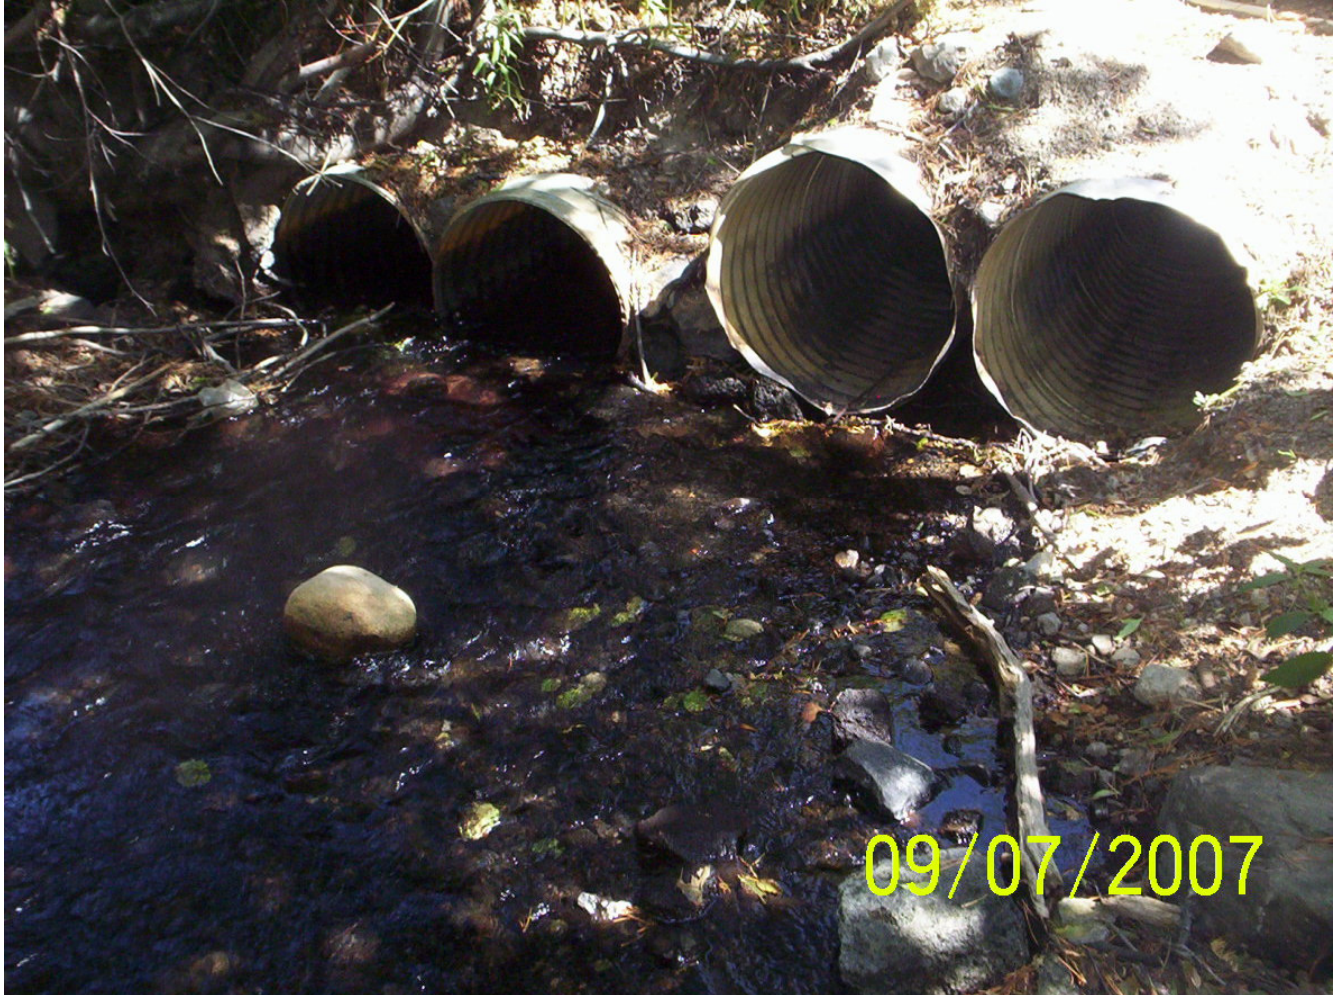
Figure B-4. A culvert installed in Reach B of Mammoth Creek as part of a driveway to provide access to a private residence.

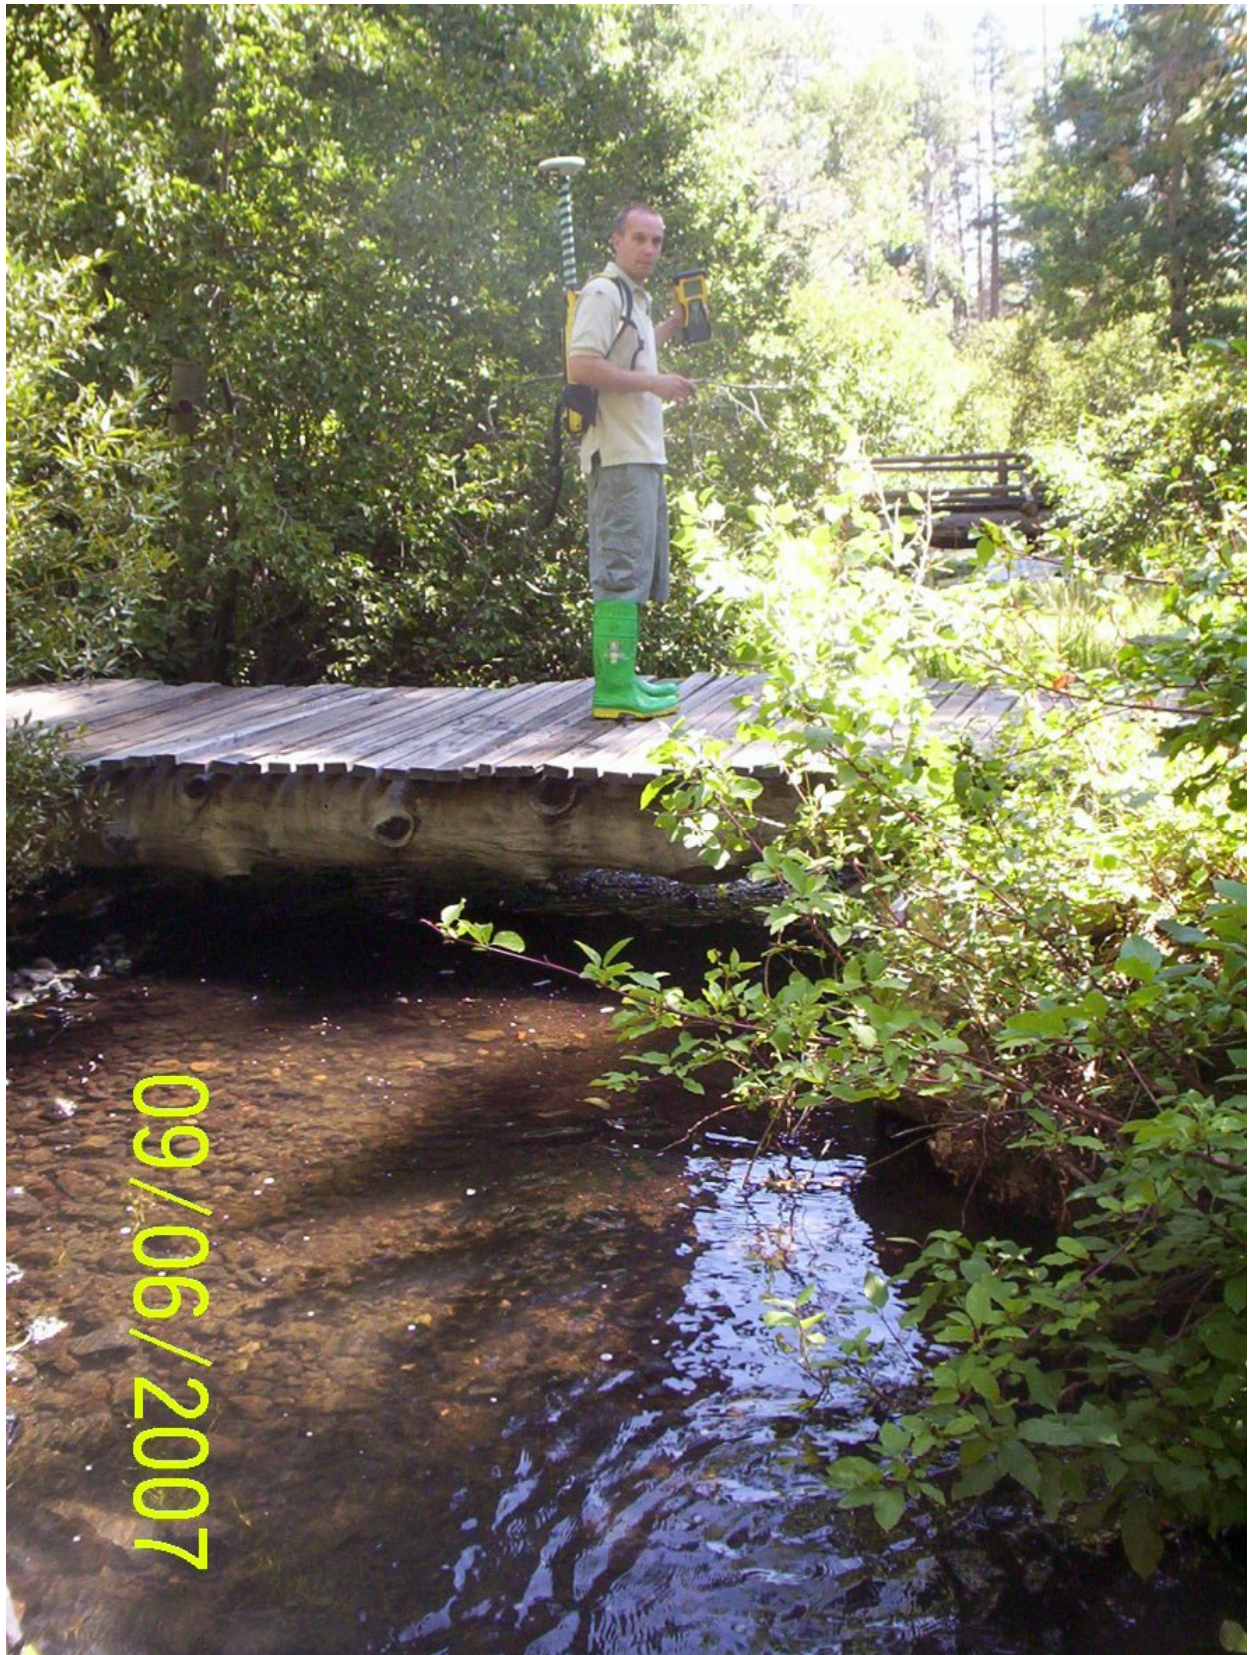
Figure B-5. Multiple bridges installed in Reach B of Mammoth Creek.

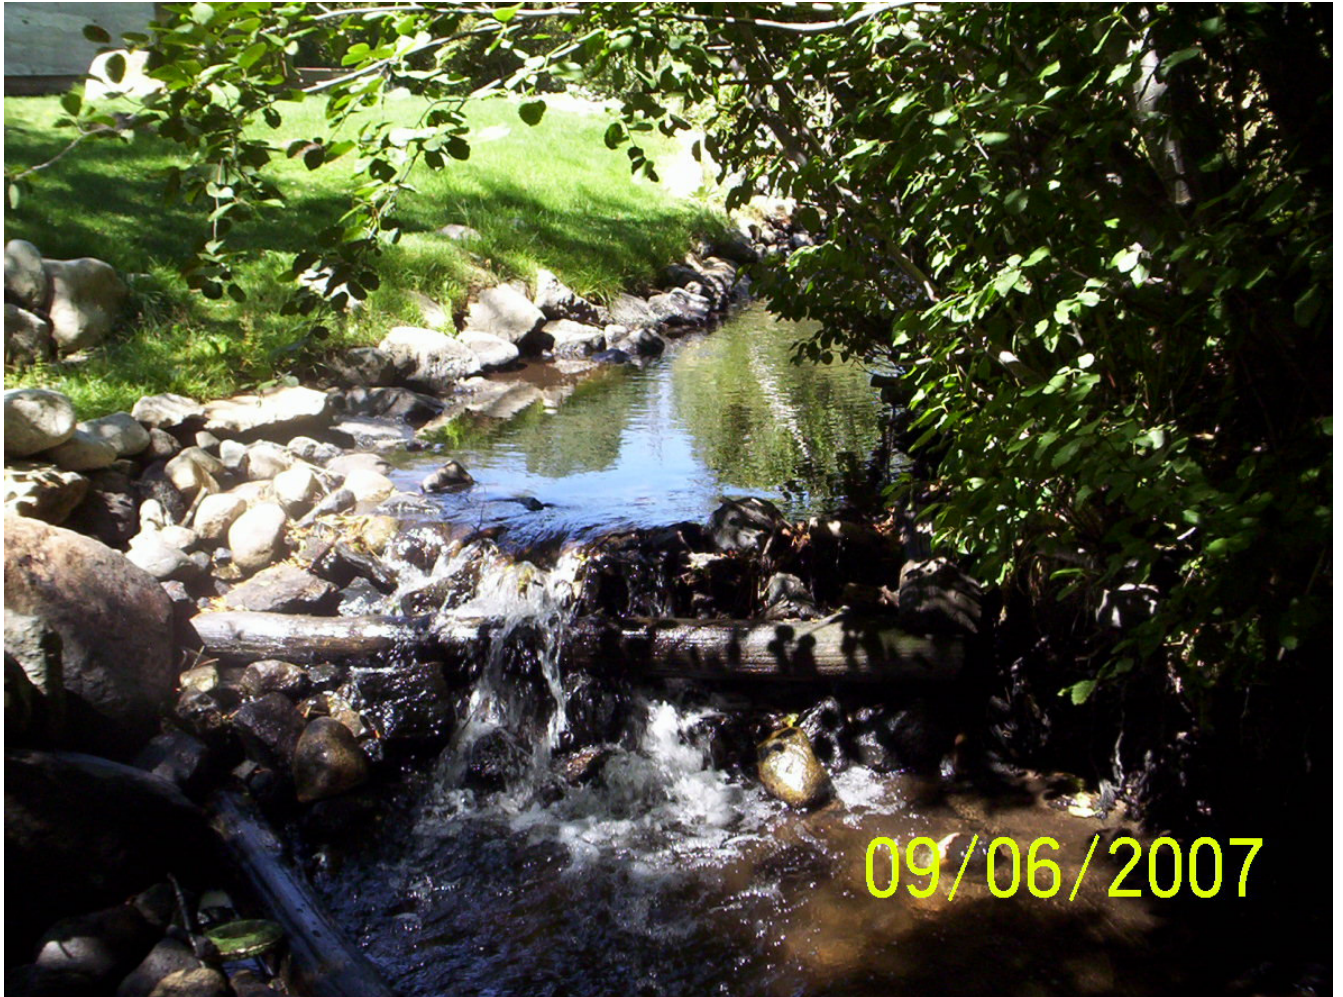
Over thirty dams were counted in Mammoth Creek between Sherwin Street and Snowcreek. Some of the instream rock dams are substantial, and may have the potential to act as a fish barrier under low flow conditions. Two dams were observed on many parcels, and one parcel had six rock dams installed within a small section of the creek.

Figure B-6. One example of instream rock dams constructed in Reach B of Mammoth Creek. Some of the instream rock dams are substantial, and may have the potential to act as a fish barrier under low flow conditions.

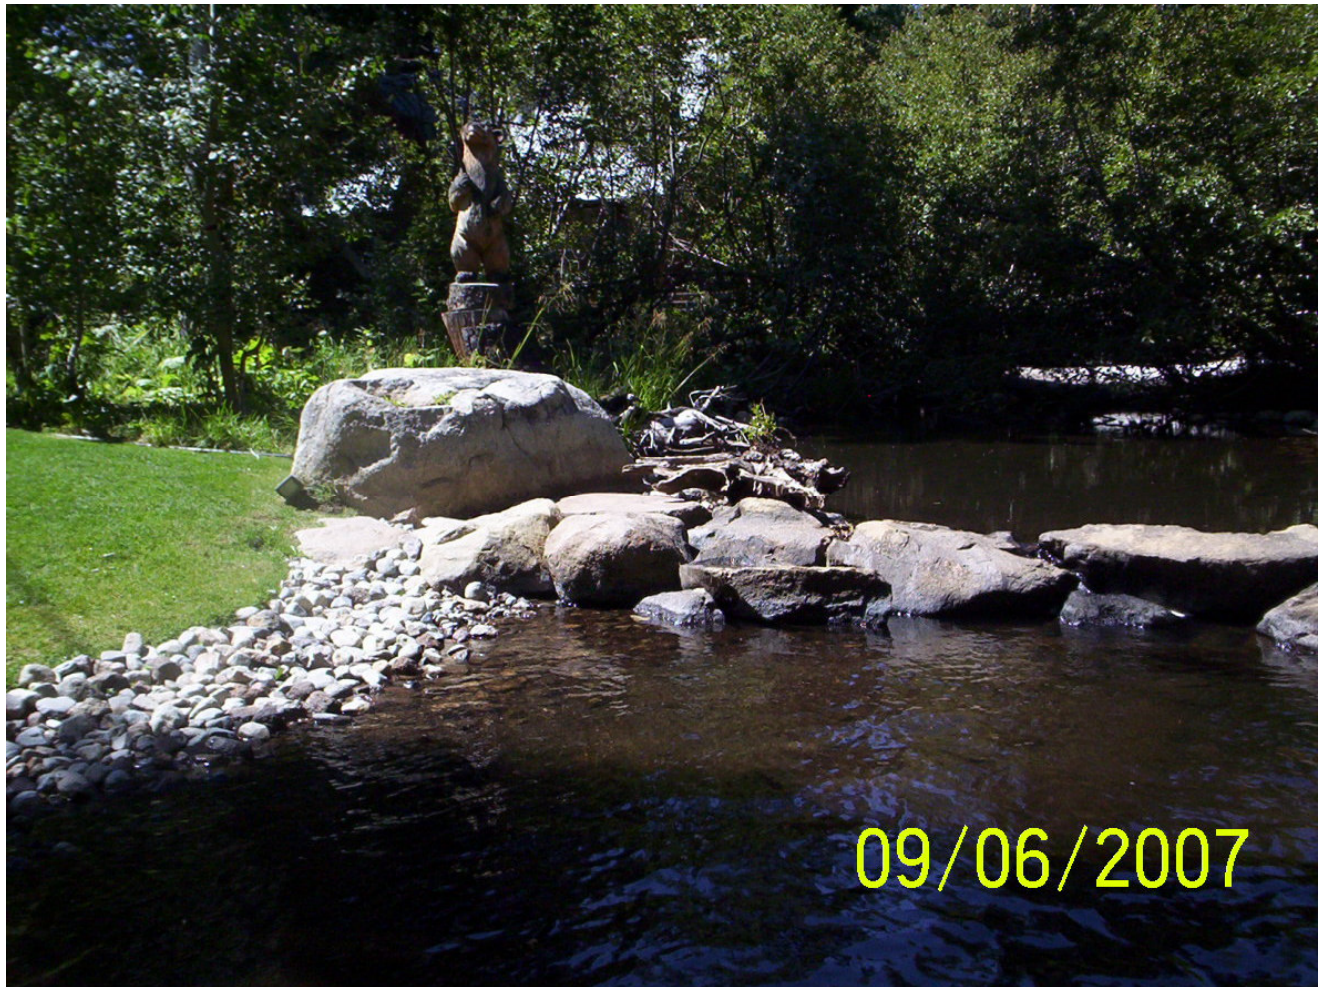
In addition to various residential development construction-related effects, many homeowners have directly influenced the creek in other ways. Twenty-two parcels between Snowcreek and Sherwin Street have modified the aquatic habitat of Mammoth Creek through the construction of rock dams within the creek, installing bridges over the creek, or installing turf directly up to the creek banks. Other influences include the installation of “drainpipes” directly feeding into the creek from unknown sources, creation of diversions and additional man-made channels, the dumping of grass clippings in the creek, and the installation of artificial decorative rock walls along the creek banks. One of the most common situations noted during the visual survey of Reach B of Mammoth Creek was the apparent reduction in water velocity associated with the installation of rock dams, which appear to have caused localized siltation in the creek.

Figure B-7. One example of a private parcel exhibiting grass installation up to the creek bank, rocks installed along the creek bank, and an instream rock dam.
